RETROFITTING AND RE-INSTALLATION OF AIR CIRCUIT BREAKERS

Low Voltage Switchboard Equipment
Publication RET 2010

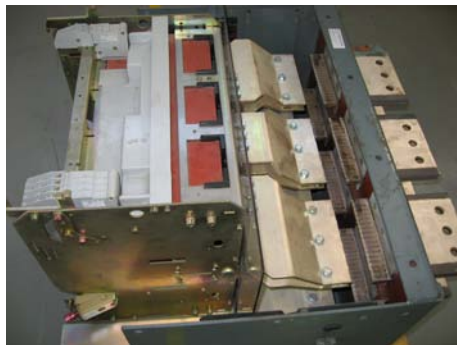
New w/drawable ACB installed into UNELEC C9 3150A ACB

Each combination of original and replacement ACB utilizes a specifically designed kit. This comprises a base plate that fixes to the original sub-chassis and provides a platform for the new ACB sub-chassis. A set of extension bars connect between the termination bars on the new sub-chassis to the existing connection stabs on the existing sub-chassis. These bars have the plug-in contacts built into them when the fingers are part of the original ACB. (Very few ACB's have the fingers on the sub-chassis.) No parts of the original ACB (including isolating contact clusters) are re-used.
